Chapter 2

DESCRIPTION OF THE WATER BODY

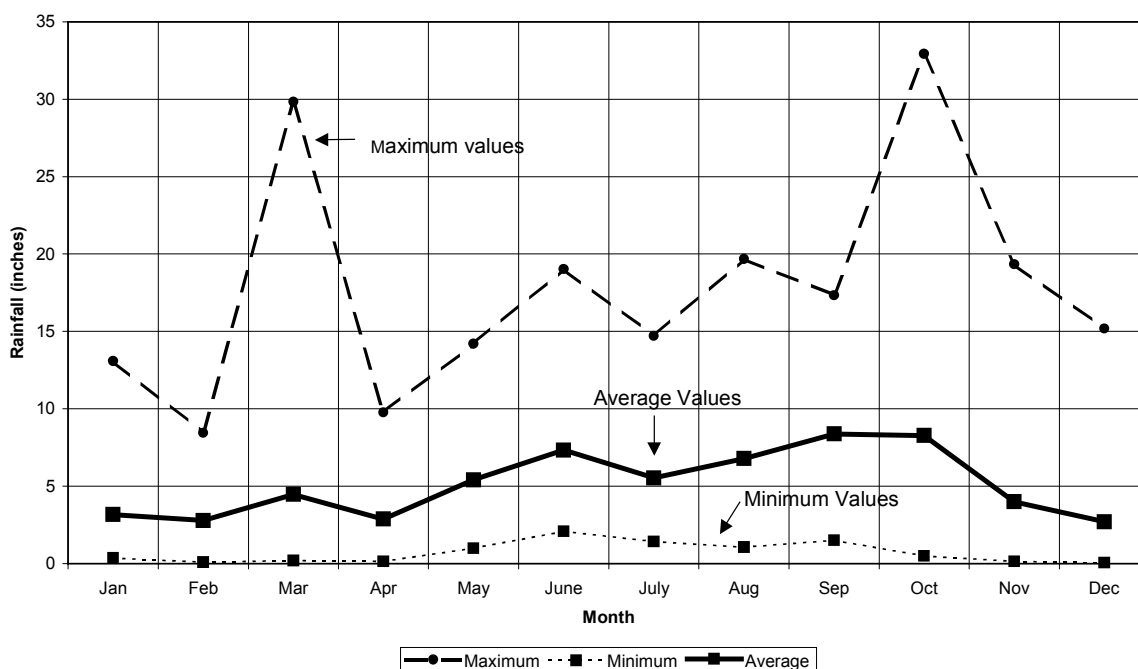
Figure 3. Average, Minimum and Maximum Rainfall by Month for the Jupiter Area (1900-1990)

Rainfall within the Loxahatchee River watershed averages about 61 inches annually (Breedlove, 1982) with heaviest precipitation occurring during the wet season. Based on average monthly precipitation a “wet” and “dry” season can be established. For the period of record 1900-1995, the majority of rainfall (67%) occurs from May through October (**Figure 3**). In contrast, only 33% of this total falls during the dry season (November-April). On average, the highest rainfall occurs during the months of September and October (8.3-8.4 inches/month) while minimum average values range between 2.7 and 2.8 inches/month for the months of December, February and April (**Figure 3**). During the winter and early spring there are some years in which there are long periods of time in which there is little or no rainfall, resulting in a regional drought condition (e.g. 1971, 1981, 1989/90). In contrast, tropical storms or hurricanes over the area can produce as much as 6 to 10 inches of rainfall in one day. Total annual rainfall can be as much as 110 inches or as low as 39 inches.

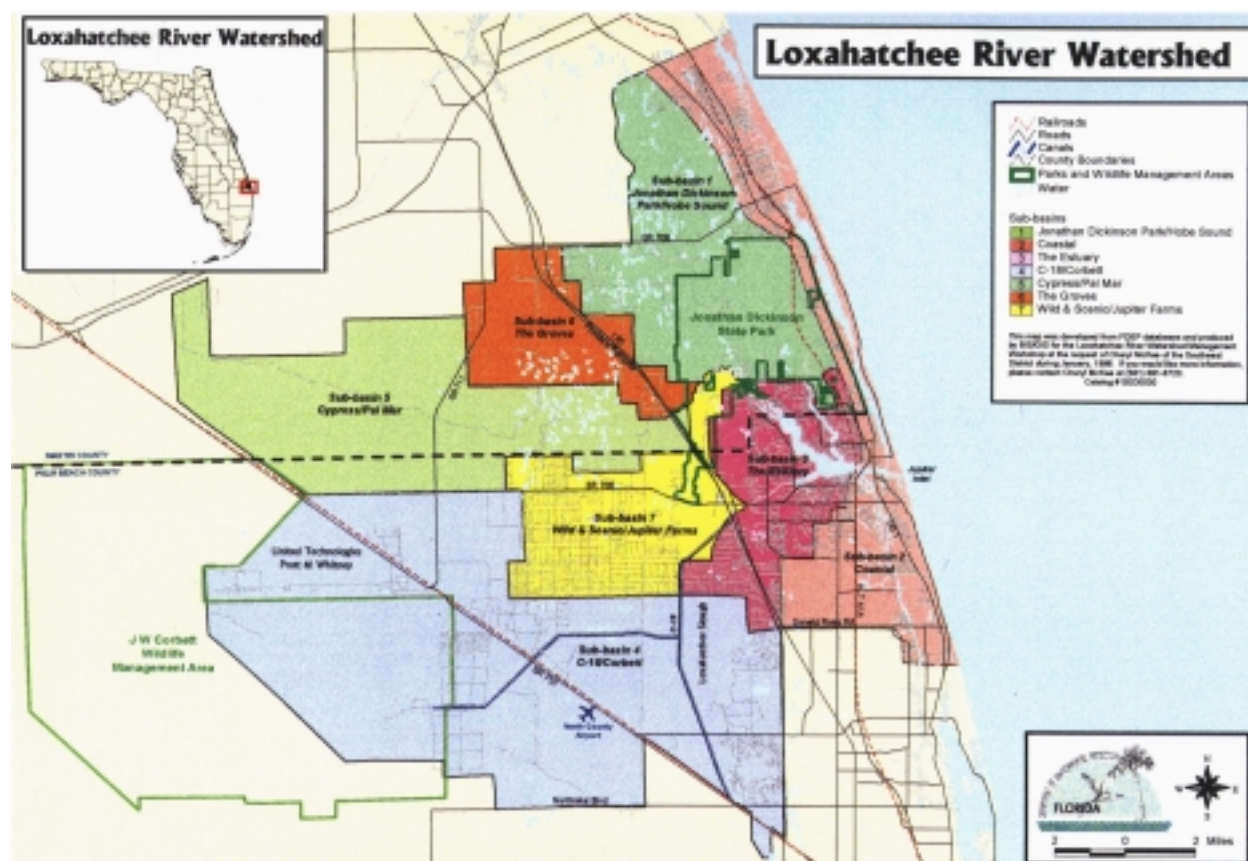
Figure 4. Subbasins of the Loxahatchee River watershed (from FDEP, 1998).

The watershed contains seven drainage basins, varying in size from seventeen to one hundred square miles, which provides runoff to the three forks of the Loxahatchee River (**Figure 4**). The subbasin boundaries were based primarily on hydrology and secondarily on land use. Each of these subbasins is unique and plays an important role in the watershed.

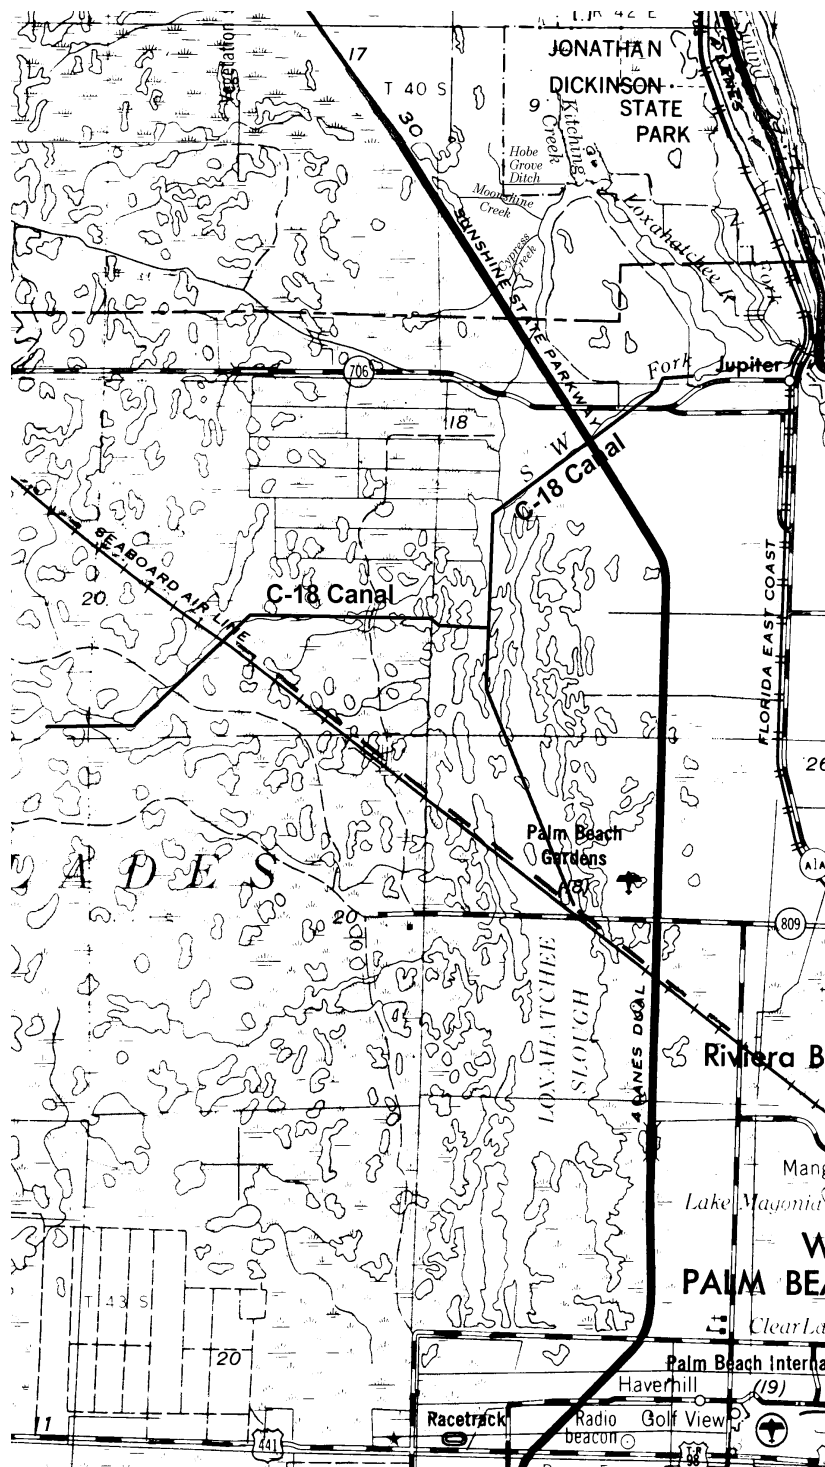
Figure 5. Major Features of the Loxahatchee River and upstream watershed System.

The main stem of the Loxahatchee River originates in the Loxahatchee Slough, a pristine cypress swamp and wet prairie wetland located southwest of the river (**Figure 5**). Outflow from the Loxahatchee Slough travels downstream through the G-92 structure and C-14 Canal to the

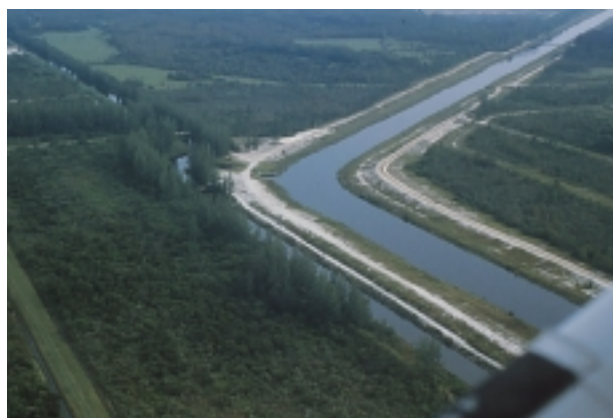
Figure 6. Location of G-92 Culvert

By the 1970's, much of the Loxahatchee Basin had been drained for residential or agricultural uses. The SFWMD placed a culvert (G-92) in C-18 in the early 1970's at the point where the Northwest Fork intersects with C-18 (**Figure 6**).

In response to public concerns that the C-18 diversion was detrimental to the unique fresh-water communities found along the Northwest Fork, this culvert was improved to deliver a sustained flow of 50 cubic feet per second (cfs) and a maximum flow of 100 cfs to the Northwest Fork. Investigations since construction of G-92 indicated that there still remained a salt encroachment problem within the Northwest Fork of the river during dry periods. During the severe drought of 1980-81, the operation of the S-46 Structure was modified to provide storage of water in the canal to recharge local municipal wellfields and reduce the amount of freshwater loss to tide. The structure would discharge to the Southwest Fork only when water levels were greater than 15 feet above mean sea level. In 1987, the capacity of G-92 was increased to allow deliveries of up to 400 cfs.

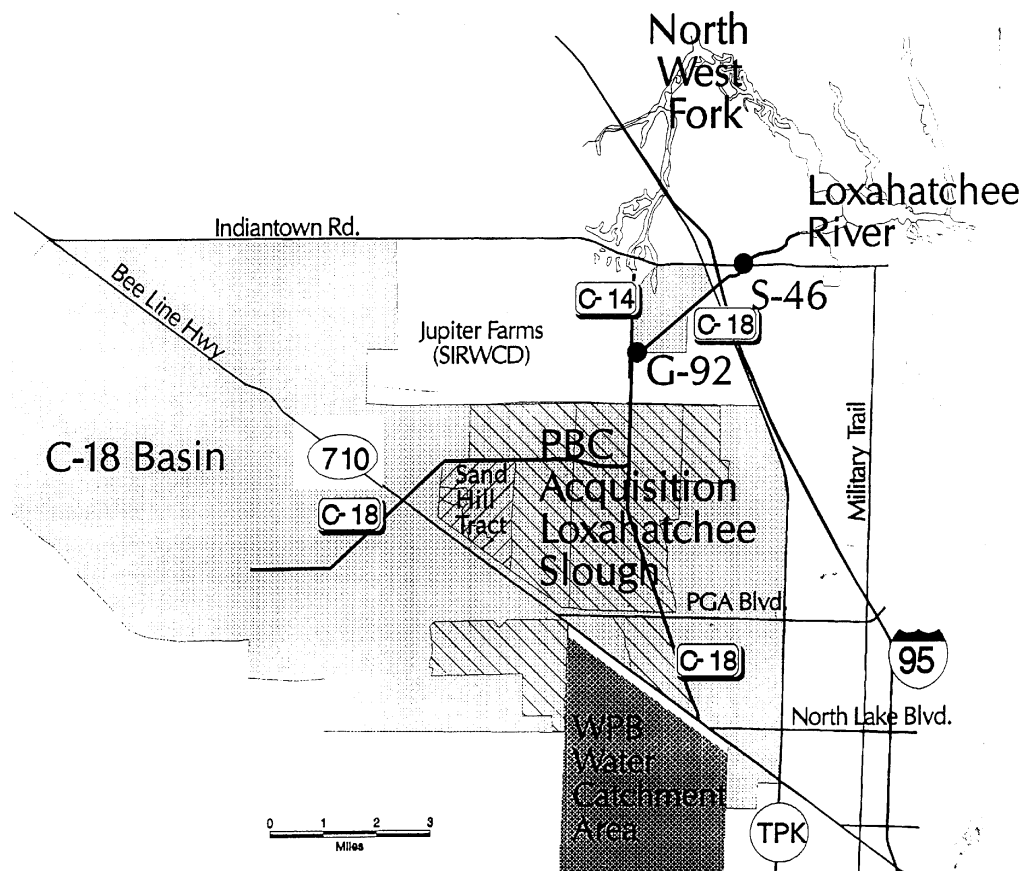
Figure 7. Major features that influence drainage within the river basin (FDEP/SFWMD 2000)

In its natural condition, the source of the Loxahatchee River was the Loxahatchee and Hungryland Sloughs located near West Palm Beach. Historically, this area was characterized by swampy flatlands interspersed with small, often interconnected ponds and streams that produced a sheet flow toward the north. Drainage patterns were determined by the poorly defined natural landforms of the area. The major features that presently influence drainage in the river basin are Canal 18 (C-18), the Florida Turnpike, I-95, and State Road 710 (which act as important subbasin divides), and the extensive systems of secondary canals developed by special drainage districts and landowners within the basin (**Figure 7**).

Much of the reduction in flow observed by the USGS has been attributed to the diversion of historic Northwest Fork flows due to construction of the C-18 canal. The C-18 drainage system is the most prominent feature in the Loxahatchee River basin. The C-18 was constructed in 1958 as part of the Central and South Florida Flood Control Project to improve drainage and flood protection for adjacent agricultural, residential, and industrial land as well as the J.W.

Corbett Wildlife Management Area. This system drains a 106 square-mile area (more than 50 percent of the river basin), and empties into the Southwest Fork through control structure S-46. The C-18 canal is of particular significance because it (a) drained the Loxahatchee Slough, and (b) redirected water that historically flowed from the Slough to the Northwest Fork into the Southwest Fork of the Loxahatchee River. The other major drainage system in the Loxahatchee River basin is maintained by the South Indian River Water Control District (SIRWCD). It lies west of C-18 in an area known as Jupiter Farms. This area has been subdivided and sold as residential tracts ranging in size from one to five acres. Drainage occurs through a series of seven east-west collector canals into Canal 14 (C-14), and a North-South canal administered by SIRWCD. The C-14 discharges directly into the Northwest Fork just South of the bridge at Indiantown Road.

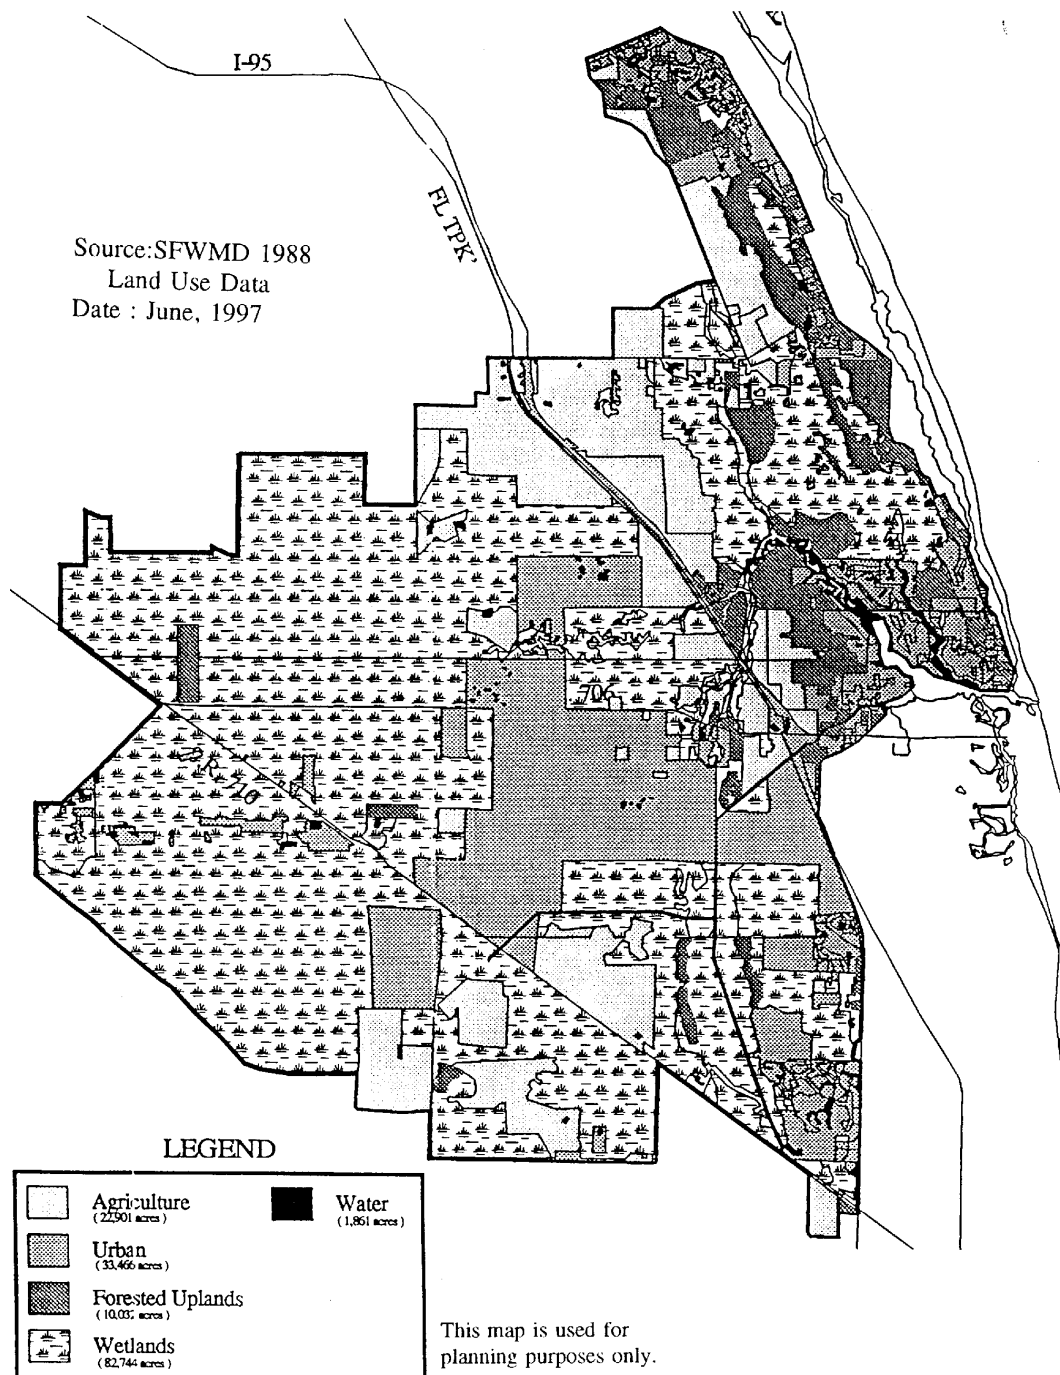
Figure 8. Current generalized land use/land cover in the Loxahatchee watershed (from FDEP/SFWMD, 2000)

Land in the river's watershed has most typically been converted to urban uses. The extreme southeastern section of the basin along the eastern edge of Loxahatchee Slough is one of the fastest developing areas in the basin. Another major area of land development is located in

the central portions of the basin, both east and west of C-18. Jupiter Farms, located west of the Loxahatchee River and south of Indiantown Road, is one example of the type of land development activity that has occurred in this portion of the basin. This 9,000-acre subdivision was platted in the 1920s and consists of parcels generally ranging in size from one to five acres.

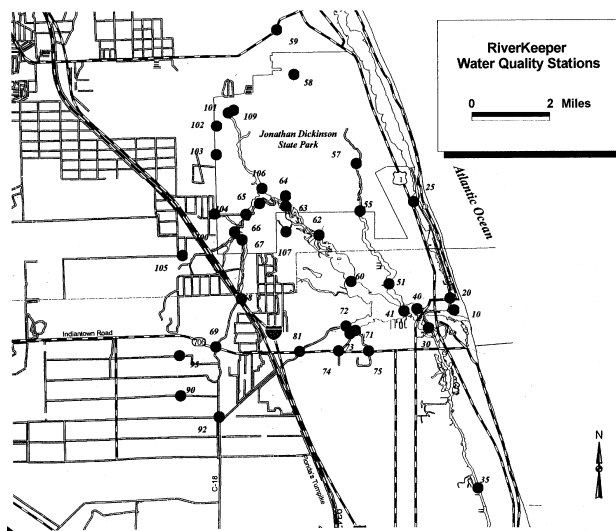
Figure 9. Water Quality Stations Sampled by the Loxahatchee River District

Seven reaches or groups of stations have been monitored over the years within the Wild and Scenic portion of the Loxahatchee River. Additionally, six sampling sites are located in the freshwater tributaries flowing into the designated corridor. **Figure 9** shows the applicable water quality sampling sites.

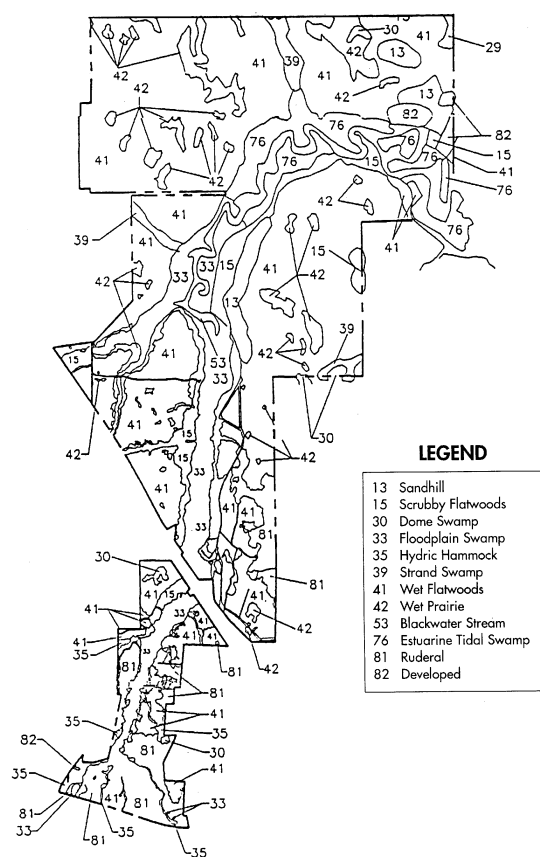
Figure 10. Wild and Scenic Corridor Plant Communities within Jonathon Dickinson State Park.
(Source: FDEP/SFWMD, 2000)

Low pine flatwoods and scrubby flatwood communities occupy the slightly higher elevations bordering the floodplain. Other vegetation communities found in the area include sandhill, cypress dome swamp, hydric hammock, cypress strand swamp and wet prairie. The cypress swamp community solidly flanks the river and its tributaries upstream from the Trapper Nelson Interpretive Site, and is the dominant community for approximately one mile below the

site. This community is composed of bald cypress, southern red maple, cabbage palm, pop ash, pond apple, laurel oak and water hickory. Shrubby species mixed among the taller vegetation include cocoplum, wild coffee, myrsine, and buttonbush. Vines, ferns, bromeliads and orchids also are characteristic of this community.

The mangrove community lines the Northwest Fork from approximately one mile downstream of the Trapper Nelson Interpretive Site. Red mangroves front the river where they are most fully exposed to tidal flows. Some dead cypress trees tower above the red mangroves for approximately three quarters of a mile downstream from this point, evidence of the extent of freshwater vegetation that existed before changes in the upstream movement of salt water. White mangroves are somewhat removed from the river channel but near enough to be inundated at high tide.
